Effect of Clinical Use on the Cyclic Fatigue Resistance of ProTaper Nickel-Titanium Rotary Instruments

The resistance of ProTaper (Dentsply Maillefer, Ballaigues, Switzerland) nickel-titanium rotary instruments to cyclic fatigue was examined after their initial use in straight or curved canals in vivo. These instruments were rotated freely inside a steel phantom until separation. The number of rotations before failure and the lengths of the separated fragments were compared with data derived from new instruments under the same experimental setup ($n = 20$). With the exception of F1 and F3, instruments previously used in curved canals were more susceptible to cyclic fatigue than those previously used in straight canals ($p < 0.05$). Separation occurred predominantly at the D10 to D12 level. For the F series, a negative correlation ($p < 0.05$) was observed between the number of rotations before failure and the file diameters at their separation levels. ProTaper F3 instruments are highly susceptible to cyclic fatigue failure and should be reused with caution irrespective of whether they are initially used for shaping straight or curved canals. (*J Endod* 2007;33:737–741)

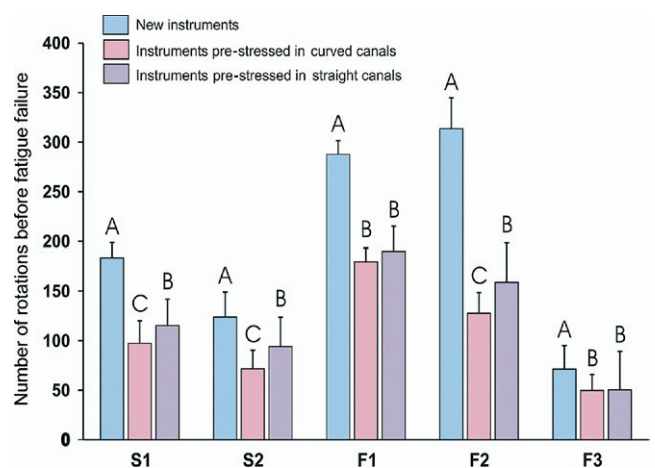
Figure 1. A histogram comparing the number of rotations required for fatigue failure of the different ProTaper instruments after they were prestressed *in vivo* in straight or curved root canals. New instruments were used as the control. For each of the five instrument types examined, columns labeled with the same letters are not statistically significant ($p > 0.05$). F3 was the most susceptible to cyclic fatigue failure irrespective of whether it was prestressed in a straight or curved root canal.

The RTFs (means \pm standard deviations) of the new S1, S2, F1, F2, and F3 ProTaper instruments were 183.5 ± 25.3 , 123.8 ± 13.8 , 287.7 ± 31.1 , 313.6 ± 23.9 , and 71.2 ± 6.7 , respectively. The RTFs of the S1, S2, F1, F2, and F3 instruments that had been prestressed in curved canals were 97.3 ± 18.7 , 71.6 ± 13.7 , 179.6 ± 20.9 , 127.6 ± 16.2 , and 49.7 ± 5.9 , respectively. The RTFs of the S1, S2, F1, F2, and F3 instruments that had been prestressed in straight canals were 115.2 ± 29.5 , 94.1 ± 25.2 , 190.0 ± 39.7 , 158.8 ± 38.9 , and 50.3 ± 11.3 , respectively. These results are graphically represented in Figure 1. For all file types, the RTFs of new instruments were significantly higher than the used instruments ($p < 0.05$). The S1, S2,

and F2 instruments that were prestressed in straight canals exhibited higher RTFs than those that were prestressed in curved canals (Fig. 1). There were no differences between instruments that were prestressed in straight or curved canals in the F1 and F3 instruments ($p > 0.05$). For the length of the separated fragment, there was no difference between the two prestressing modes for each type of instrument ($p > 0.05$). Separations occurred predominantly at the D10 to D12 level. By using file diameter data supplied by the manufacturer, a negative correlation ($p < 0.05$) was observed in the F series between the RTFs and the corresponding file diameters at their separation levels (Fig. 2).

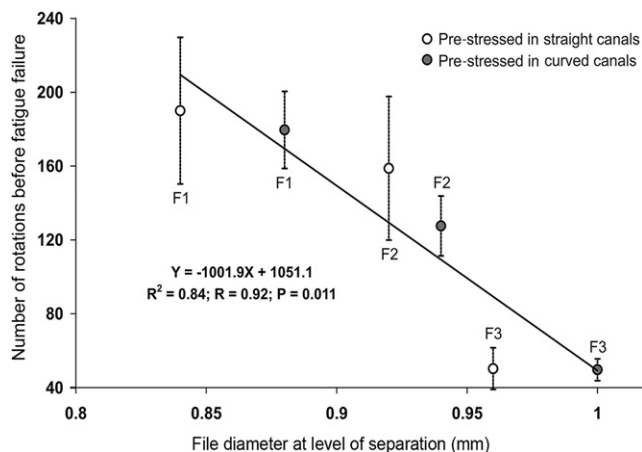
Figure 2. Linear regression analysis of the ProTaper F series of finishing instruments showing a significant negative correlation between the number of rotations to fatigue failure and the corresponding file diameters (data obtained from the manufacturer) at their separation levels.

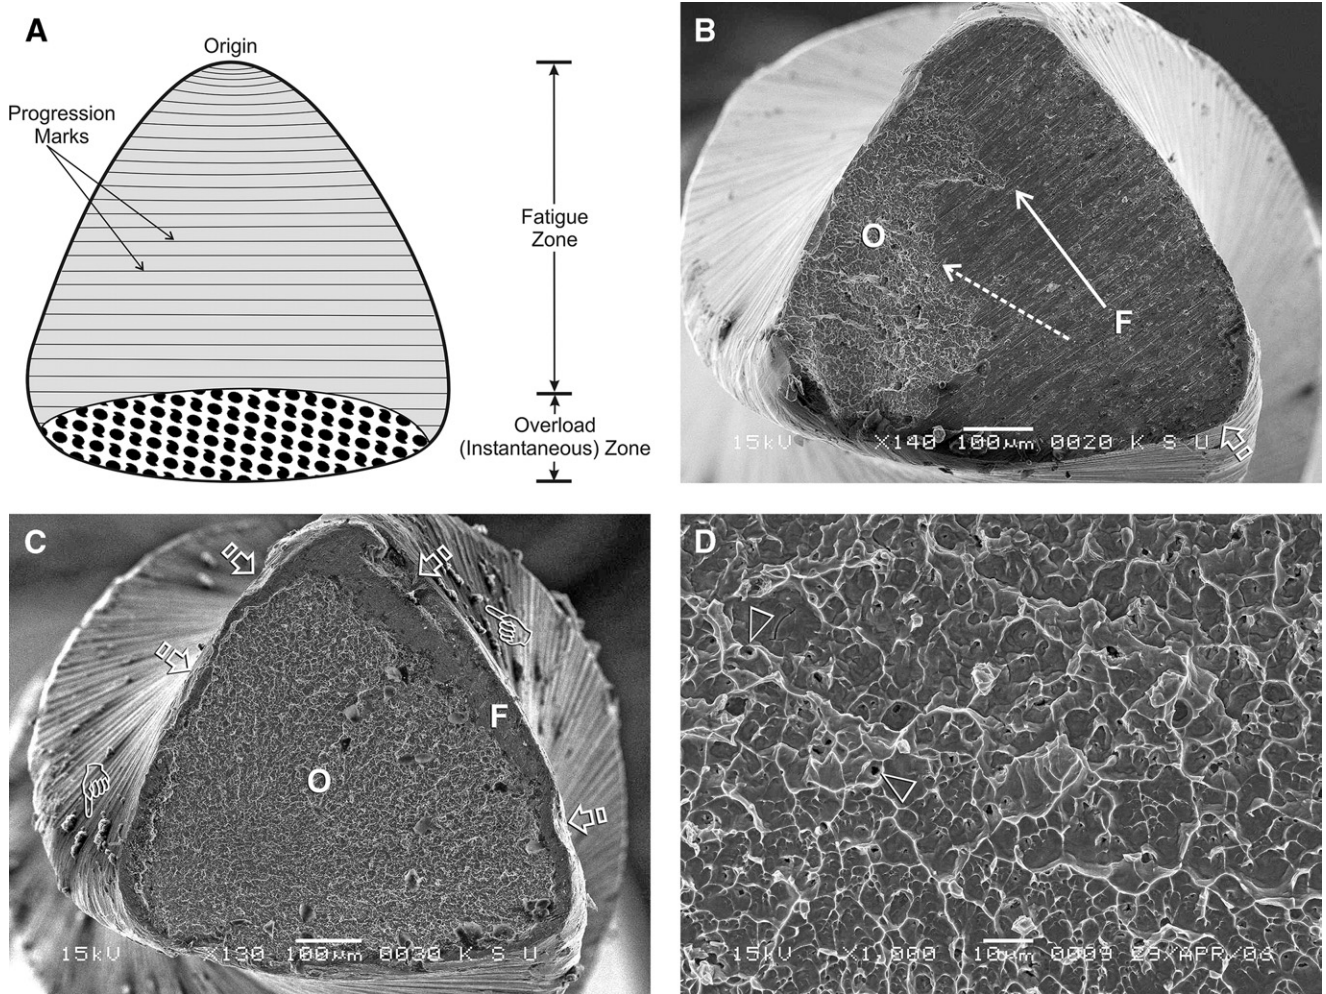
Figure 3. (A) A schematic representation of predominant surface features found in fatigue failure. (B) A scanning electron micrograph of the fractured surface obtained from a new instrument (S2 ProTaper) that has been subjected solely to in vitro cyclic fatigue stresses. The large, relatively smooth fatigue zone (F) was probably initiated by a defect along the machined instrument surface (open arrow). Progression marks along the surface of the fatigue zone represent variations in the component stresses as the crack propagated in the direction indicated by the solid arrow. The eccentricity between the direction of slow crack growth (solid arrow) and the bisector (dotted arrow) of the overload zone (O) is indicative of a clockwise rotational bending failure. (C) A scanning electron micrograph of the fractured surface obtained from a clinically used instrument (F1 ProTaper) that was further subjected to in vitro cyclic fatigue failure. Debris was found along the machined instrument surface (pointers) after clinical root canal shaping. The relatively small fatigue zone (F) and a large overload zone (O) suggests that most of the fatigue life of the instrument was spent in the original crack formation, creating a heavy stress concentration that quickly led to instrument failure. The centrally located overload zone indicated that the failure was initiated at multiple locations (open arrows) around the perimeter of the shaft and then grew inward. (D) A high-magnification view of a typical overload zone revealed evidence of dimpled rupture that is characteristic of the ductile nature of the ultimate catastrophic failure. A large population of microvoids (open arrowheads) could be seen within the nickel-titanium material.

Fractographic analysis revealed features that are characteristic of fatigue failure (23). These features are schematically represented in Figure 3A. They included a relatively flat and smooth “fatigue zone” where fatigue crack propagation occurred in response to cyclic stresses and a rougher “overload or instantaneous zone” representing the site of the final catastrophic failure. Progression marks were evident at low magnification along the “fatigue zone” that depicted load variations during the advancement of the crack front as well as the direction of crack propagation. New instruments that have not been used clinically exhibited smaller “overload zones” that were either close to or affiliated with one edge of the triangle (Fig. 3B). Instruments that have been prestressed clinically in curved canals exhibited large, centrally located “overload zones” (Fig. 3C). A high magnification of the “overzone zone” revealed evidence of dimpled rupture and the presence of multiple microvoids within the fractured alloy (Fig. 3D).

Fractographic analysis is an integral part of cyclic fatigue testing because it reveals the history of the fractured interfaces that enables one to distinguish cyclic fatigue failures from those precipitated by quasi-static loads. Although all the in vitro separated instruments exhibited evidence of cyclic fatigue fracture (Fig. 3A), differences in how the instruments were handled before separation could be conjectured from the fracture histories of new and used instruments. For the new instruments, the smaller overload zones that were usually affiliated with one edge of the separated instrument (Fig. 3B) are indicative of a localized origin of crack initiation, a longer period of comparatively slower crack propagation, and a lower stress magnitude during the instant of rupture (23). Crack initiation could have been initiated by a surface flaw produced during the machining of these instruments. Conversely, the larger, more centrally located overload zones seen particularly in instruments used previously in curved canals (Fig. 3C) are indicative of

multiple origins of crack initiation, and these instruments were heavily stressed at the time of final fracture. The multiple stress concentration sites could have been precipitated by slip planes or microcracks that were generated along the instrument surface during clinical use (30). These crack-initiation stresses were probably magnified by dentin chip embedding and wedging (31) because debris remained on the instrument surface even after sonication cleaning (Fig. 3C). The relatively small fatigue zones that accompanied large overload zones suggest that most of the fatigue lives of the used instruments were spent in the crack initiation phase. However, once cracks were initiated, they propagated rapidly, creating heavy stress concentrations that rapidly spread inward and quickly led to failure along the center of the instrument shafts. For both the new and used instruments, the eccentricity between the "fatigue zones" and "overload zones" inferred a history of rotational bending instead of plain bending before fatigue frac-

ture (27). The presence of extensive microvoids and the evidence of dimpled rupture within the overload zones (Fig. 3D) are characteristic of ductile fracture (32). The latter occurred by coalescence of microvoids (33) and resulted in plastic deformation of the remaining overloaded part of the ProTaper instruments (16, 34) as the propagating cracks attained critical sizes (35).
