## So, you fractured an instrument, what can you do?

Rafaël Michiels, DDS, MSc

This was a case which was sent to my office, because the referring dentist could not prepare one of the mesial canals of a lower right first molar.

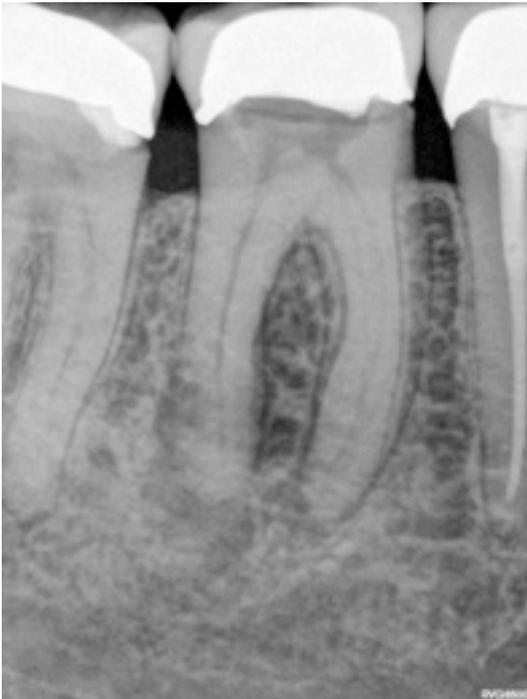
*Diagnostic X-ray*

It was obvious that there was chronic apical periodontitis. Also 2 mesial canals were visible. Furthermore the crown did not fit the tooth, there was a large space between the edge of the crown and the tooth (clinical image 1)

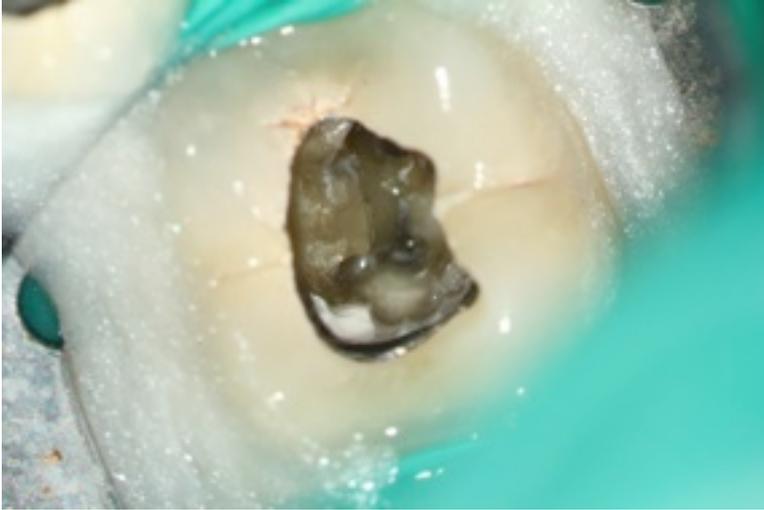
*Clinical image 3*

After removing the temporary restoration I found the opening cavity to be still full of calcified dentin, overhanging dentin, etc. However, two mesial canals were immediately visible.

I made the opening cavity complete and started creating a glide path in all canals. This took me a long time, but eventually I had managed to create a glide path in all three canals up to a size 20. I used a lot of K-files 08 and 10 for this and afterwards the Pathfiles from Maillefer. From then on I switched to Protapers. After having shaped the D and MB canal with a Protaper S1, I decided to take a new S1 (so my second new Protaper S1 for this tooth), because I had encountered a lot of resistance, even with a glide path. I got to working length in the ML canal with the S1. After cleaning the instrument and irrigating the canal, I decided to take it one more time to working length -----> FAIL! It fractured. A 7mm piece was now in the apical part of the ML root.

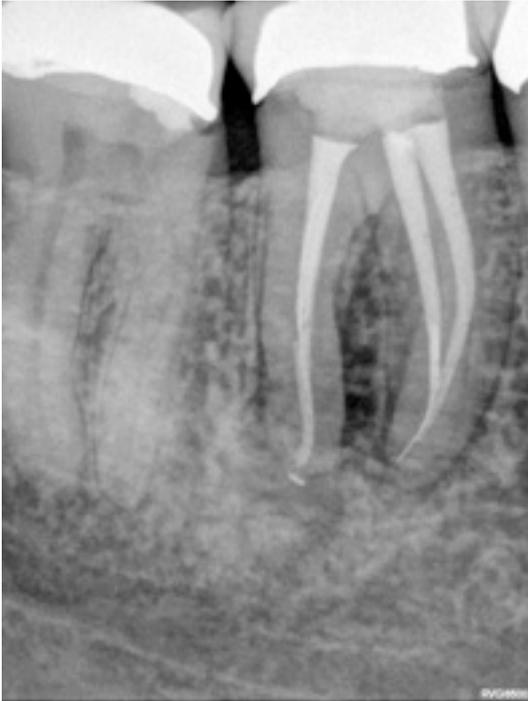
*Result*

The tooth was eventually temporarily restored with glass ionomer cement. The prognosis is good, even with the fractured instrument, but follow-up is necessary.
