## Technical note

# Detection of dentinal cracks using contrast-enhanced micro-computed tomography

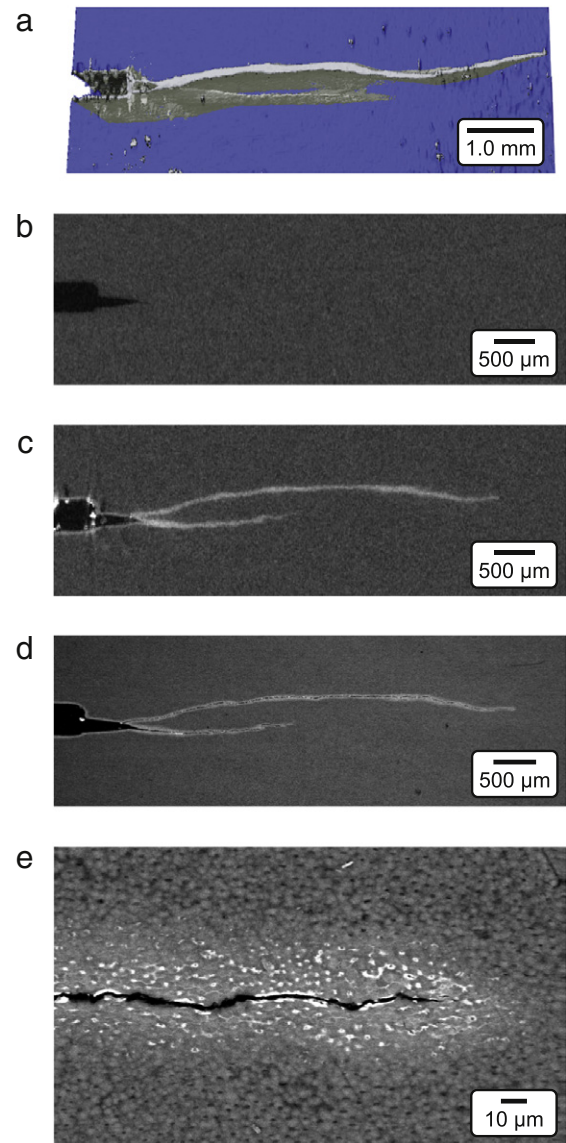
**Fig. 1** – A branched crack that propagated from a notch (left) in a compact tension specimen of elephant dentin was imaged by micro-CT before and after staining by BaSO<sub>4</sub> precipitation, and by backscattered SEM after staining by BaSO<sub>4</sub> precipitation. (a) A segmented, three-dimensional micro-CT reconstruction showed crack surfaces stained with BaSO<sub>4</sub>. Cross-sectional grayscale micro-CT images at the same depth approximately midway through the specimen thickness (b) before and (c) after staining by BaSO<sub>4</sub> precipitation showed that the crack was unable to be detected at this location without the use of the contrast agent. The contrast-enhanced micro-CT image in (c) was compared to (d) a backscattered SEM micrograph for the same specimen at approximately the same cross-sectional depth and magnification. (e) A backscattered SEM micrograph of the crack tip in (d) at higher magnification showed BaSO<sub>4</sub> penetration into microtubules. Note that the presence of elemental Ba and S was verified by EDS (not shown).

Contrast-enhanced micro-CT enabled non-destructive, 3-D imaging of the presence, morphology and spatial location of dentinal cracks in machined specimens (Fig. 1) and whole human molars (Fig. 2). In both types of specimens, BaSO<sub>4</sub> staining provided enhanced contrast for the detection of cracks that were not able to be detected prior to staining (Figs. 1(b), (c), and 2(b)). Note that the entire 3-D volume of grayscale image slices for the specimens shown in Figs. 1 and 2 are available as movie files (.avi) in Electronic Annex 1 and 2, respectively, of the online version of this article. Backscattered SEM micrographs showed that BaSO<sub>4</sub> was precipitated on the surfaces of dentinal cracks and within adjacent tubules (Fig. 1(e)). The highest levels of image intensity for both micro-CT and backscattered SEM were shown to correspond to the presence of elemental barium and sulfur measured using EDS. At higher magnification, SEM revealed the presence of BaSO<sub>4</sub> crystals and aggregates, typically submicron but up to 5 μm in size, on the surfaces of propagating cracks and within adjacent tubules. BaSO<sub>4</sub> was also precipitated on all free surfaces, including the root canal and pulp chamber (Fig. 2(a)). Therefore, a subregion was used to remove staining of the outer specimen surfaces and reveal internal features, including cracks, in segmented 3-D reconstructions (Figs. 1(a), and 2(a)).

The feasibility of non-destructive, 3-D imaging of dentinal cracks was demonstrated *in vitro* in machined, partially fractured specimens (Fig. 1) and whole human molars (Fig. 2) using contrast-enhanced micro-CT with a precipitated BaSO<sub>4</sub> stain. BaSO<sub>4</sub> precipitation on the surfaces of dentinal cracks and within adjacent tubules enhanced the intensity of voxels in micro-CT due to the higher x-ray attenuation of BaSO<sub>4</sub>

relative to dentin. The BaSO<sub>4</sub> contrast agent enabled the detection of dentinal cracks that were otherwise not able to be detected using a standard benchtop micro-CT instrument at 10 μm resolution (Figs. 1(b), (c), and 2(b)). The total crack length measured at the free surface in the elephant dentin compact-tension specimens was unchanged before and after staining, which suggests that the staining process did not introduce artifactual damage. Furthermore, the absence of BaSO<sub>4</sub> within cracks during subsequent electron microscopy also enabled discrimination of artifactual cracks that formed during specimen preparation, for example during dehydration, from cracks that formed *in vivo* or during *in vitro* mechanical loading.

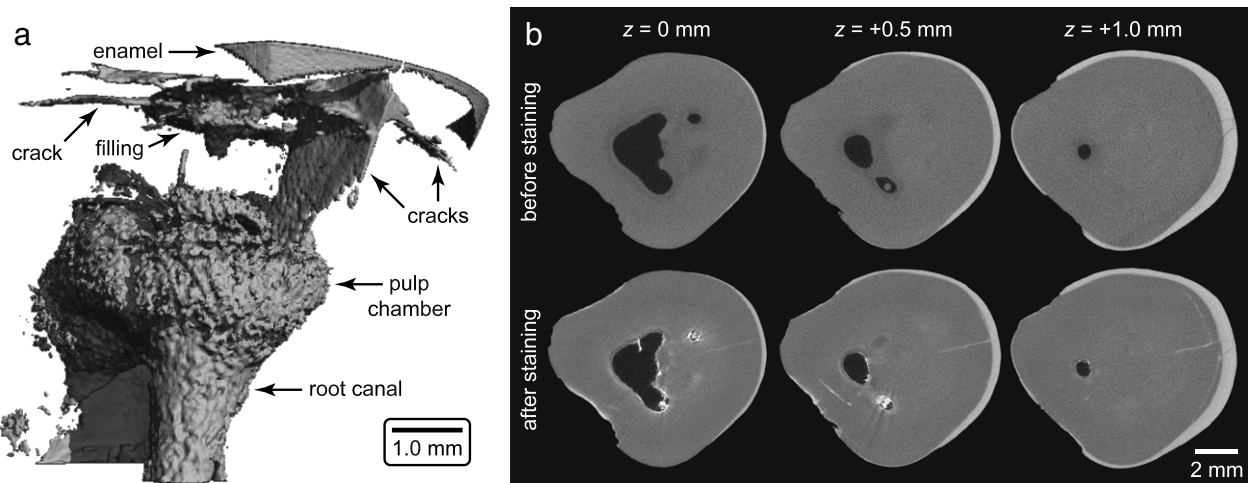
**Fig. 2** – An extracted human molar which showed evidence of cracks upon visual inspection was imaged by micro-CT. (a) A segmented, three-dimensional micro-CT reconstruction revealed internal surfaces stained by BaSO<sub>4</sub> precipitation, including the root canal, pulp chamber and cracks, and other features exhibiting the highest x-ray attenuation, including the enamel and a composite filling. Note that the majority of the enamel crown of the tooth has been excluded from the image at the top. (b) Grayscale images of transverse cross-sections showed enhanced contrast for the detection of dentinal cracks after staining by BaSO<sub>4</sub> precipitation compared to the same image cross-section prior to staining.

study the BaSO<sub>4</sub> contrast agent was difficult to distinguish from the enamel, presumably due to comparable levels of x-ray attenuation. However, cracks in the enamel were readily detected by micro-CT both with and without the use of a contrast agent (Fig. 2(b)) due to the relatively low x-ray attenuation of the fluid space in the crack compared to the enamel. Therefore, the main limitation of the difficulty distinguishing BaSO<sub>4</sub> from enamel, as well as non-specific staining of exterior specimen surfaces with BaSO<sub>4</sub>, was the need to remove the outermost voxels using contouring and a subregion analysis in order to visualize internal features in segmented, 3-D reconstructions. Last, the barium chloride and sodium sulfate staining solutions may or may not be acceptable within the oral cavity with some modification, warranting future work and potentially limiting this technique to *in vitro* studies.
