# Influence of Fractured Instruments on the Success Rate of Endodontic Treatment

**Dent Update 2008; 35: 172-179**

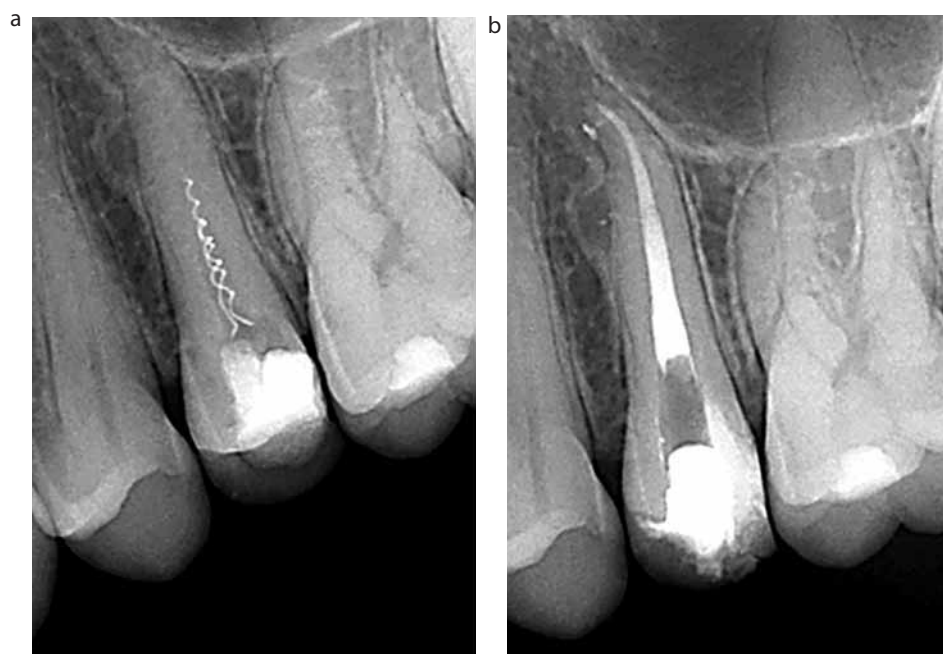
**Figure 1.** (a, b) The two fragments of a spiral filler fractured in the coronal third of the canal are an additional complication for retreatment of this tooth. The removal of these instruments makes it possible to shape, disinfect and fill the root canal conventionally.

The fragment of instrument behaves as an additional complication alongside those already existing naturally, such as the size of the canal, its curvature, calcifications, etc (Figure 1).

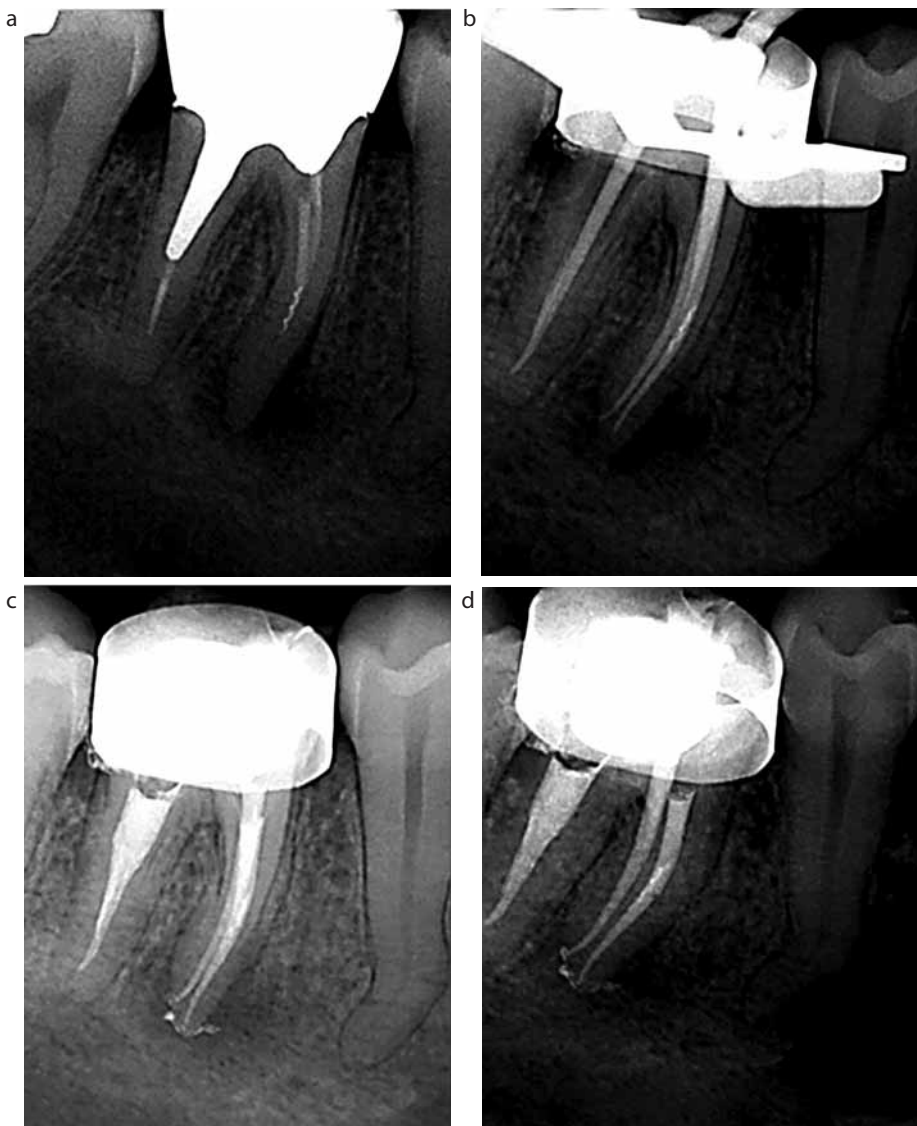
**Figure 3.** The fragment of spiral filler in the middle third of the mesio buccal root could not be removed. (a) It is by-passed, enabling the passage of endodontic files and fresh irrigant (b) to the apical root canal anatomy. The instrument has been embedded in the filling material (c, d).
