Roots Summit 3, Anaheim

Dr. Winfried Zeppenfeld

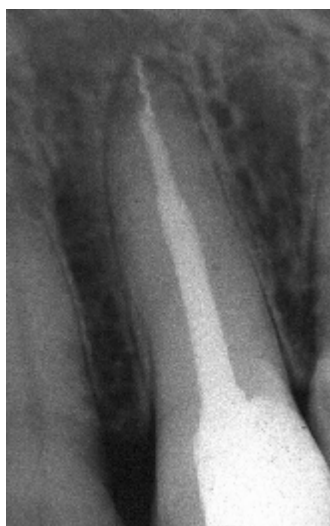
X-ray shows a root canal filling with a fractured lentulo spiral at the tip

I intended to do an apico and an adhesive repair of the crack

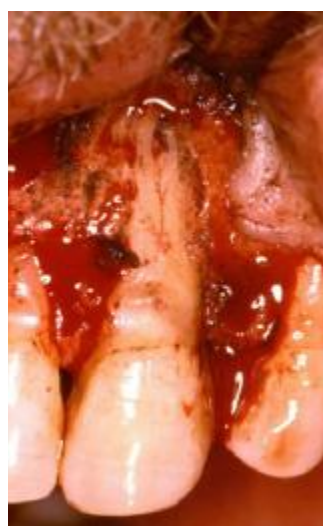
There was a crack all the way down the root and a resorption area in the middle of the root, where the patient had had the funny feeling

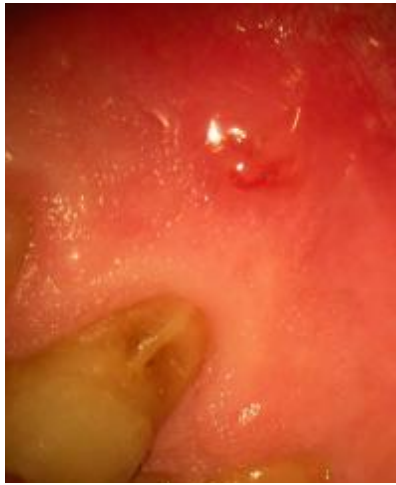
Nine months later: tooth is mobile, sinus tract in the middle of the root

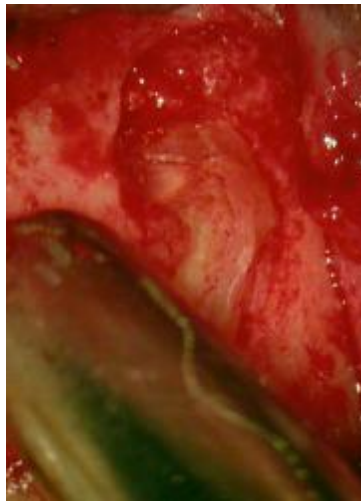
I reentered the case to see what was going on
Picture shows the repaired root and a new fracture line on the mesial aspect of the repaired area going all the way over to the palatal side: the root was split right in half.
