J Am Dent Assoc 2005;136;1286-1293

Thermal injury through intraradicular heat transfer using ultrasonic devices

Precautions and practical preventive strategies

ALAN H. GLUSKIN, D.D.S.; CLIFFORD J. RUDDLE, D.D.S.; EDWIN J. ZINMAN, D.D.S., J.D.

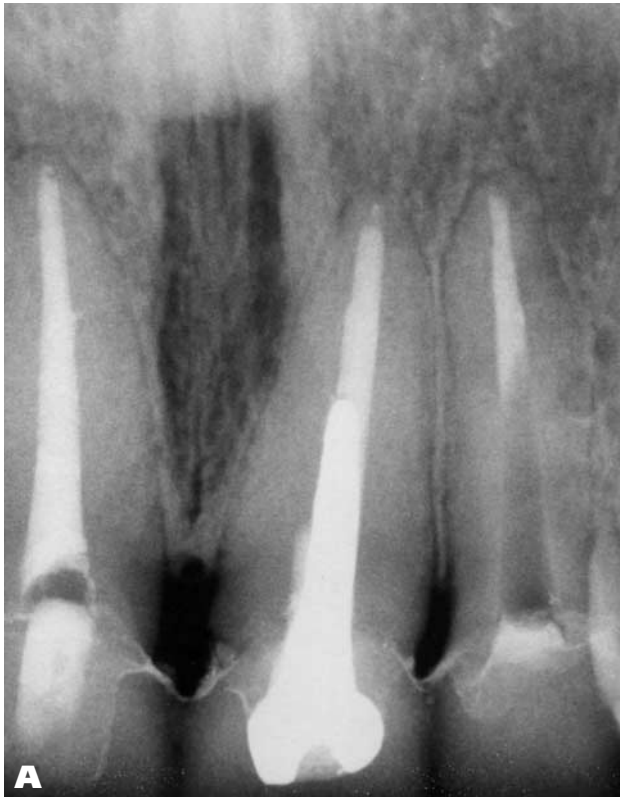
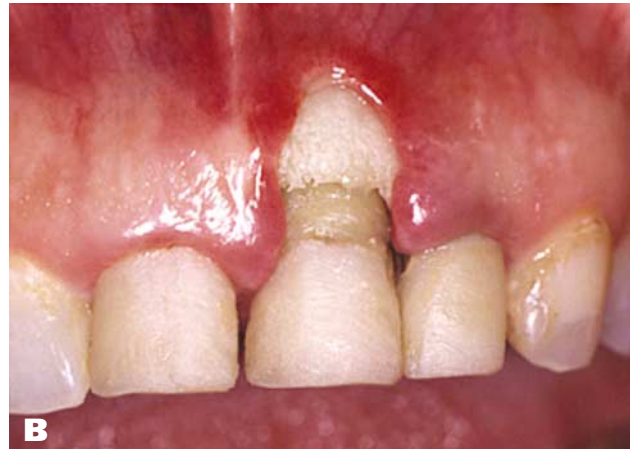
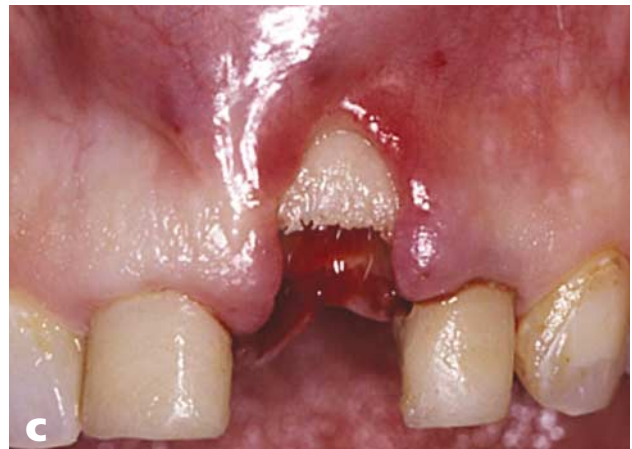
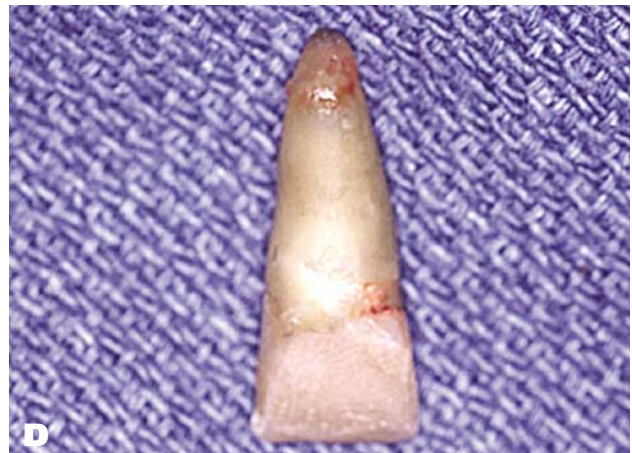
Tooth no. 9 was extracted after 48 hours owing to burn injuries to the teeth and their supporting structures that occurred during heat transfer. The patient underwent several attempts to repair the alveolar ridge by distraction osteogenesis (Figure 1).

Figure 1. A. Preoperative radiograph of a metal post in tooth no. 9. B. Postoperative photograph showing burn injuries to tooth no. 9 and its supporting structures that occurred during heat transfer. C. Tooth no. 9 was extracted 48 hours after injury took place. D. Extracted tooth no. 9 shows an absence of viable attachment to the apical one-third of the root.

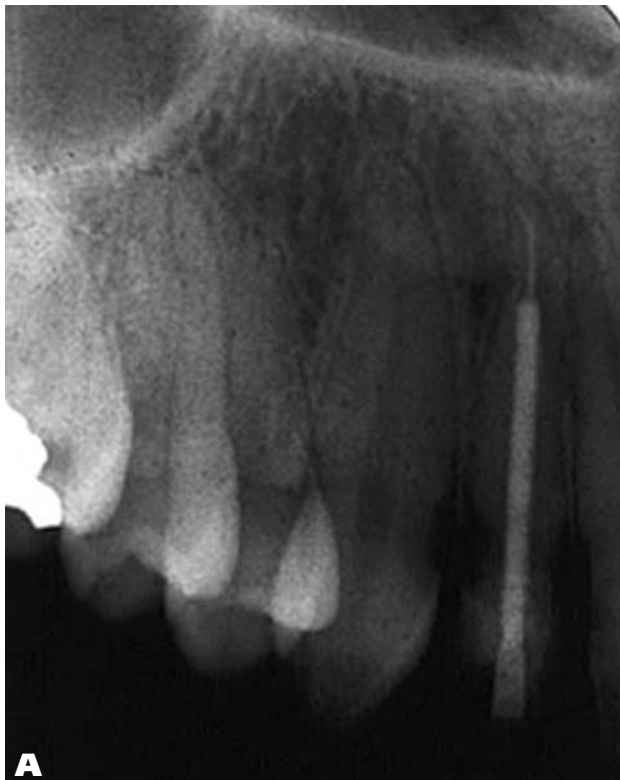
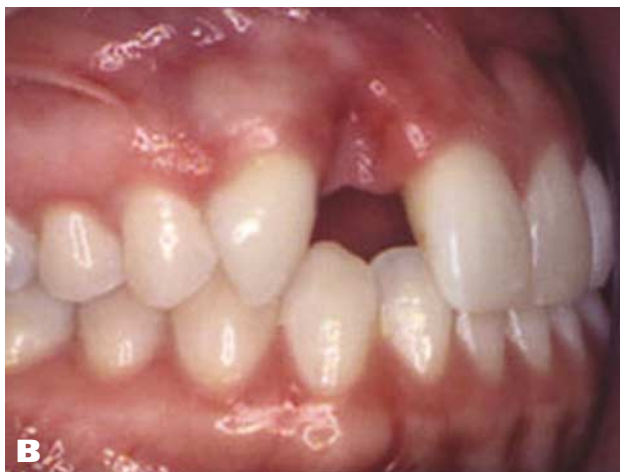
Case 2. The patient was a 35-year-old woman with a noncontributory medical history. The clinician was removing the post from tooth no. 7 because of a crown fracture that required a rehabilitation of the post-core complex and a re-treatment of the pre-existing endodontic therapy. The dentin structure of the lateral incisor was thin, and the post was long, extending to the apical one-third. The burn occurred during ultrasonic removal of the post. The loss of the tooth and bone in this case created a difficult esthetic problem for the patient (Figure 2, page 1290).

Figure 2. A. Preoperative radiograph of the post in tooth no. 7. B. Postoperative photograph showing healing of burn injury with resultant bony defect.

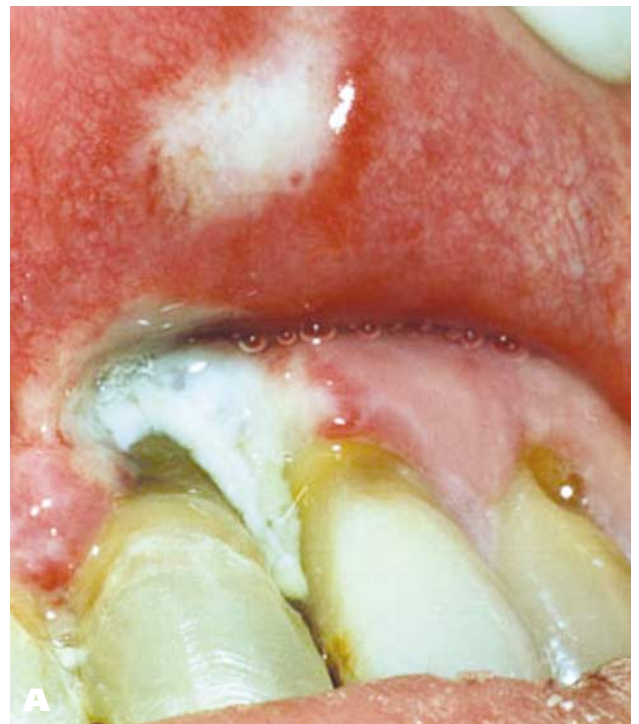
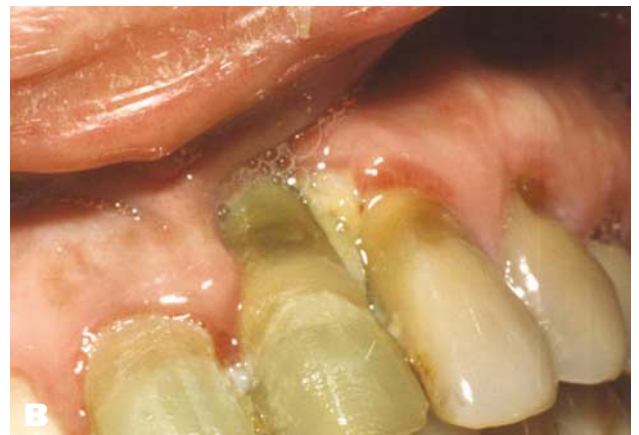
Case 3. The patient was a healthy 30-year-old woman. The clinician was replacing the posts in teeth nos. 8 and 9 for restorative reasons. The posts were negligently overheated during the attempted removal, which caused severe destruction of tissue and bone, as well as the loss of both teeth (Figure 3). Augmentation procedures were required to repair the alveolar ridge.

Figure 3. A. Postoperative burn on the gingiva and lip after the posts were removed. B. Photograph 48 hours after the burn injury occurred.

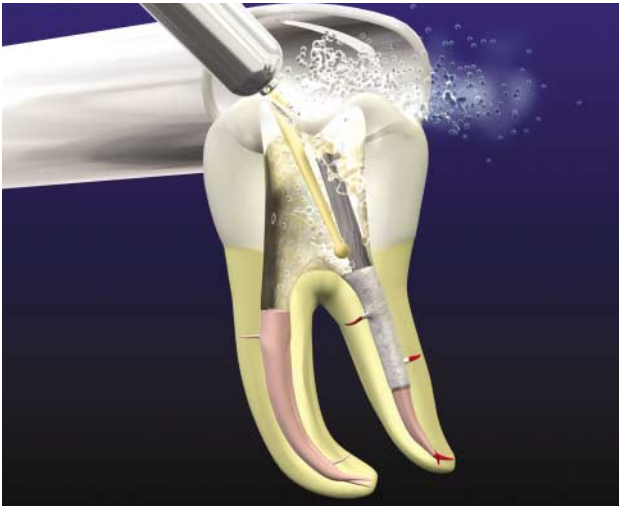
Figure 4. An ultrasonic device instrument used with copious irrigation.

potentially dislodge, the post. The selected ultrasonic device is energized at the lowest power setting that will perform the clinical task safely and is moved up, down and around the exposed length of the post. When ultrasonic procedures are performed, especially at higher energy levels for longer periods and against larger and more conductive posts, heat is generated.⁶ As such, the field should be flushed with water frequently to decrease heat buildup and the potential for dangerous heat transfer to the attachment apparatus³ (Figure 4). Fortunately, when a water coolant is used frequently and voluminously, the danger for heat transfer is minimized, and the heat is further dissipated owing to the moisture content in the attachment apparatus.^{5,6,37} In general, after removing all restorative materials from the pulp chamber, most posts can be removed safely within approximately 10 minutes.^{25,38}
