Survival Rate and Fracture Strength of Incisors Restored with Different Post and Core Systems and Endodontically Treated Incisors without Coronoradicular Reinforcement

Oliver Pontius, Dr med dent, MSD, and Jeffrey W. Hutter, DMD, MEd

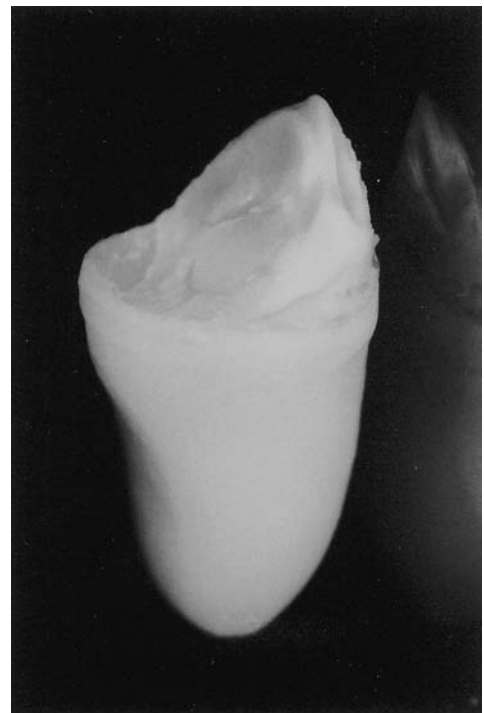
FIG 5. Fracturing of the root and RCIPC post in the artificial oral environment (group C).

Microphotographs of the samples revealed different failure modes between the experimental groups. Specimens from group A showed vertical root fractures (Figs. 2, 3, and 4), whereas those in groups C and D fractured horizontally along the CEJ (Figs. 5, 6, and 7). In group B, fracturing of the coping and core build-up, but not the zirconia post or root, occurred (Figs. 8 and 9).

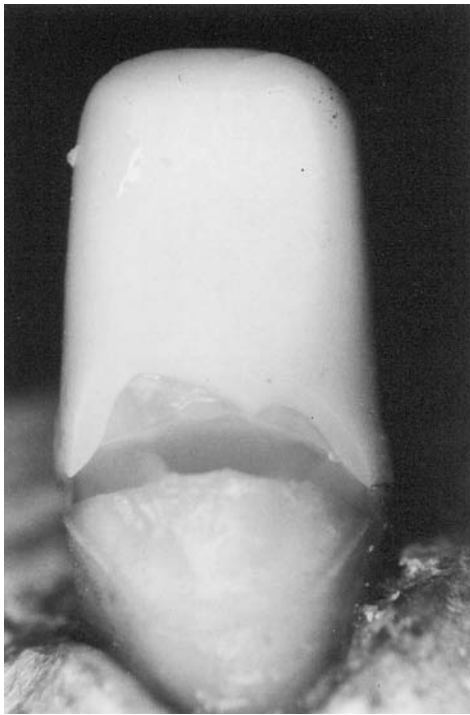
FIG 6. Failure of a specimen in the Zwick testing machine (group C).

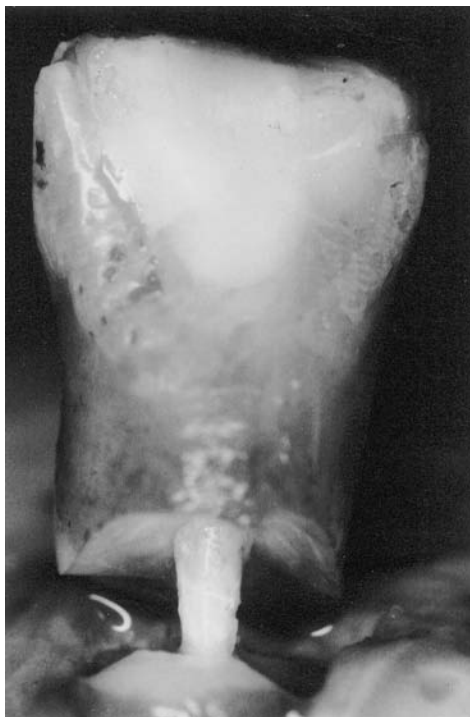
FIG 7. Failure of a specimen in the Zwick testing machine (group D).
