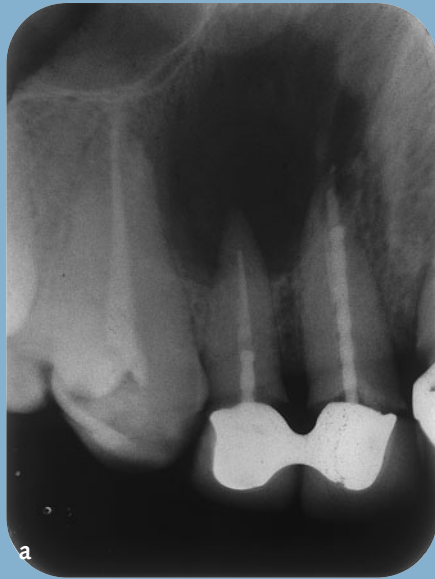
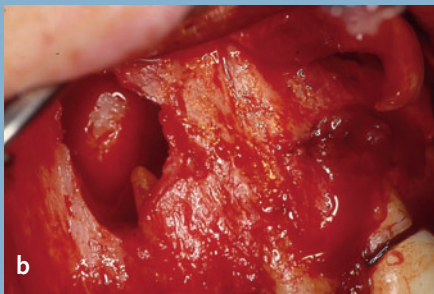
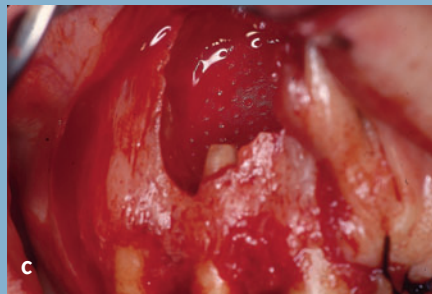
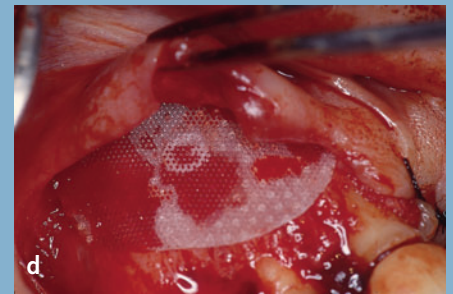
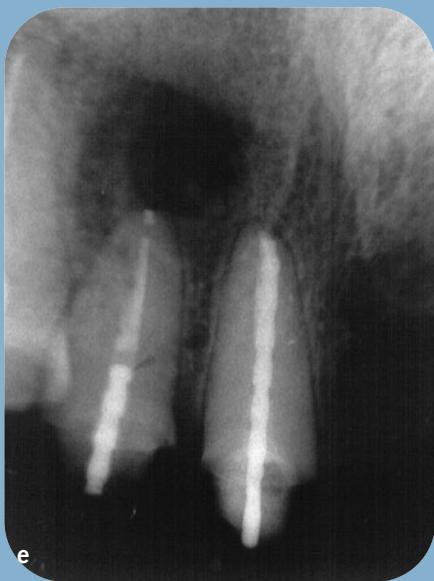
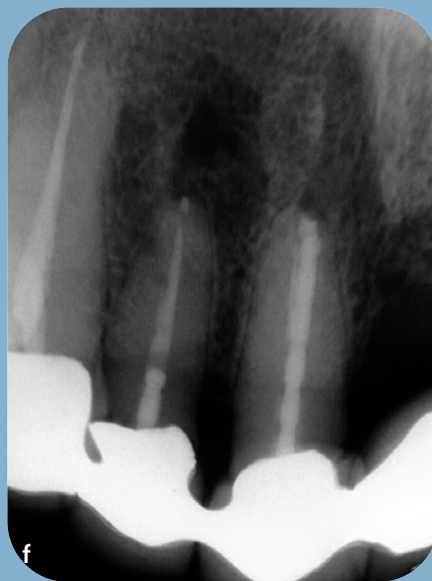
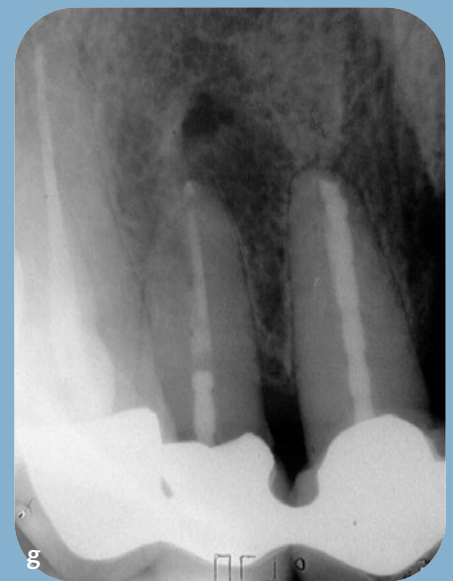
**Fig. 6-39** (a) A badly adapted bridge. Short canal treatment on the right lateral incisor with a huge bone lesion that involves the central incisor and cuspid and showing no kind of bone trabeculation in the center. (b) Palatal mucosa can be clearly seen through the buccal bone plate perforation. (c) and (d) Two Guidor resorbable membranes were used, one against the palatal mucosa and bone plate and another against the buccal bone plate. (e) to (g) Radiographic follow-up at 1, 3 and 5 years.
